### Health and Safety Report

<b>District</b>	<b>Location</b>	<b>Project #</b>
Fallsburg CS	Jr/ Sr. High School	036-1617
<b>Site Visit Date(s)</b>	<b>Investigation type</b>	<b>Investigator(s)</b>
10/6/16	Lead in water	Jesse Morrill

## **Project summary**

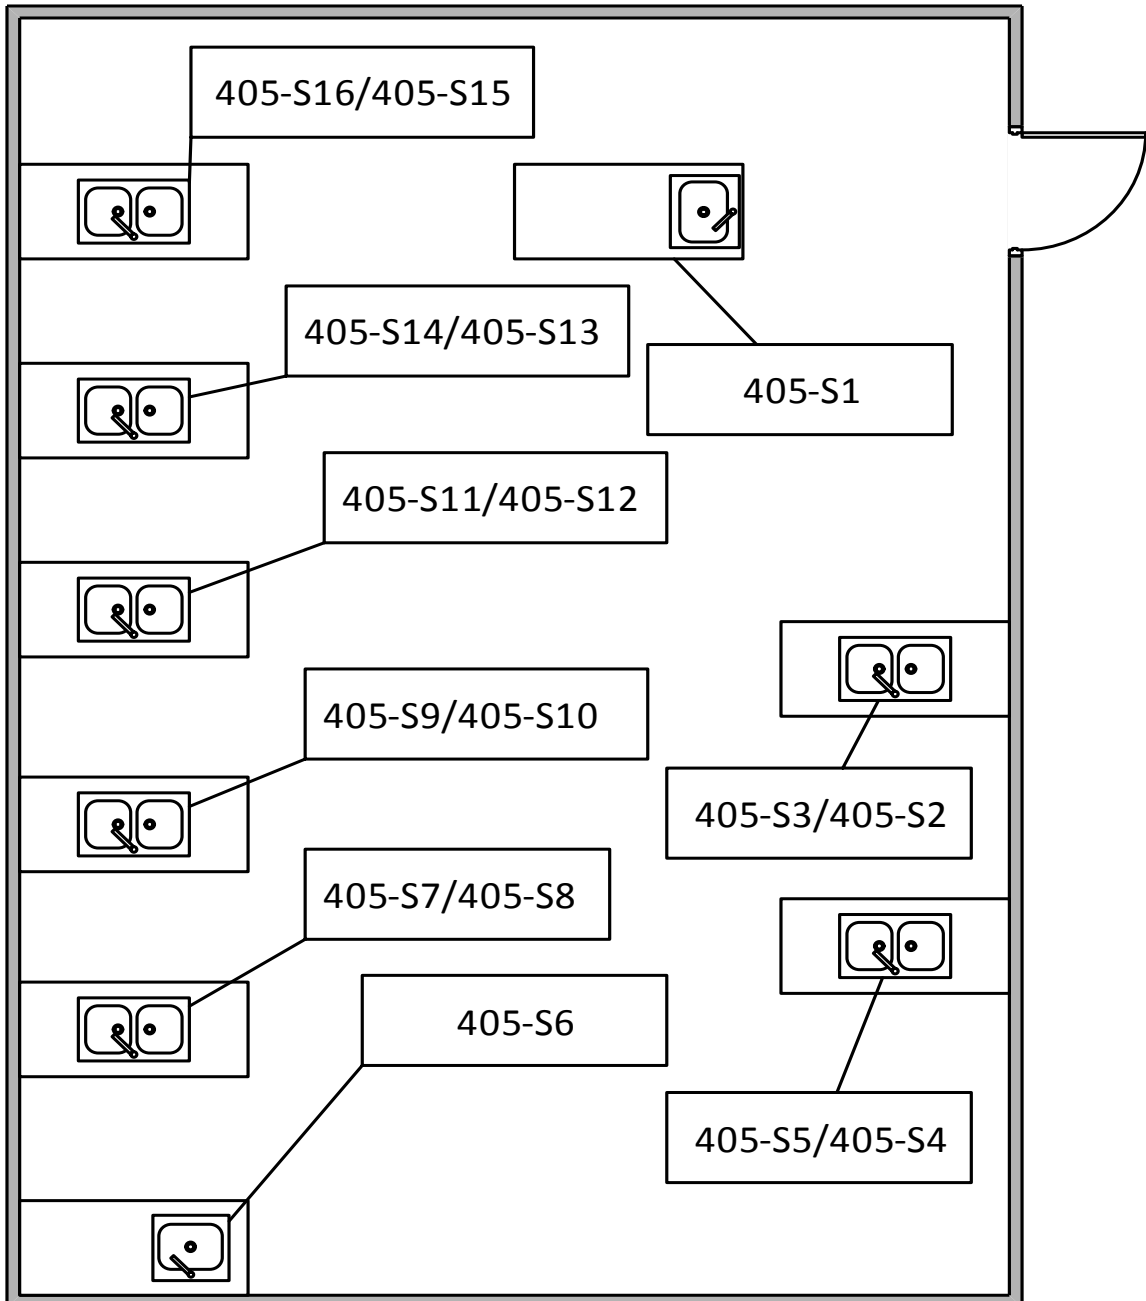
High School room 405 sample map

012-S1	30.1	✘					
308-S2	32.7	✘					
318-S3	106	✘					
401-S1	29.6						✘
401-S2	18.7						✘
401-S5	23.1						✘
401-S6	48.8						✘
401-S8	26.2						✘
401-S9	46.1						✘
401-S10	30.5						✘
405-S1	121						✘
405-S2	219						✘
405-S3	77.9						✘
405-S4	117						✘
405-S5	19.9						✘
405-S7	26						✘
405-S8	47.4						✘
405-S9	29.8						✘
405-S10	18.6						✘
405-S11	23.8						✘
405-S12	23.8						✘
405-S13	35.7						✘
405-S14	18.1						✘
405-S15	47.5						✘

405-S16	156							X
HB-2	36.2			X				
320-S1	18.9		X

Approved *response actions* for outlets exceeding the *action level* under Subpart 67-4 includes taking the outlet out of service while a remediation plan is implemented and follow up testing is conducted to ensure lead levels are below the action level. When a drinking or cooking outlet is taken out of service, the district shall provide an alternative water source while remedial actions are taking place.
